Home Inspection Report

**Inspected by:
Nick Tolman
Aventine Home Inspections**

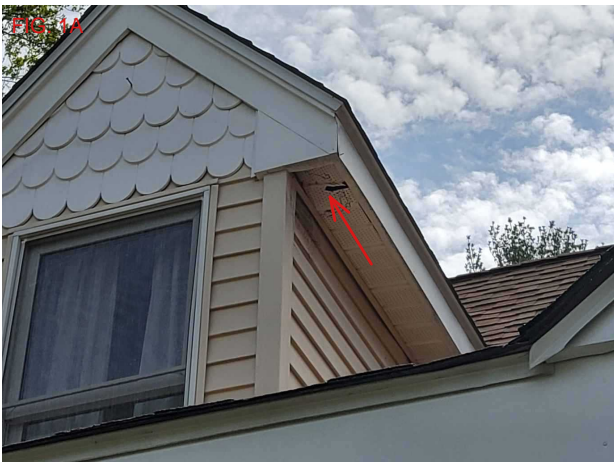
Type: Vinyl siding - **LOOSE SIDING-** Loose siding was noted on the structure's exterior. The siding should be repaired by a qualified professional (FIG. 1A).

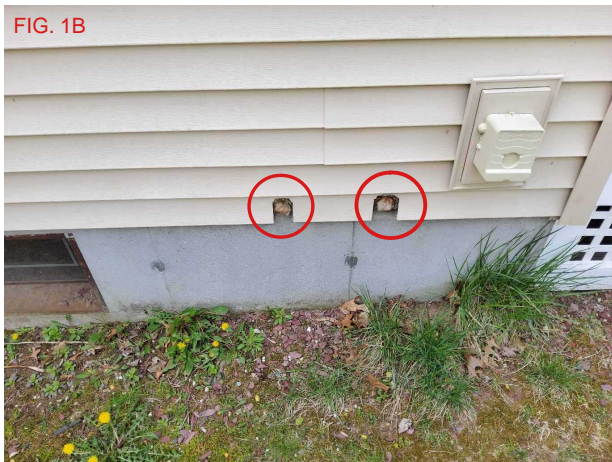
SIDING HOLES- Holes were noted in the siding of the structure's exterior. The area should be repaired by a qualified professional to prevent water intrusion (FIG. 1B).

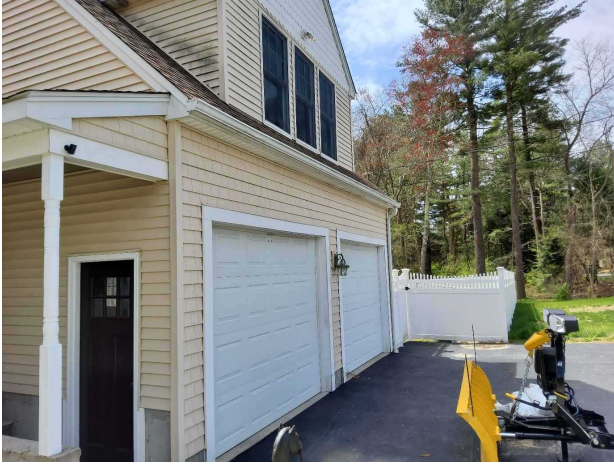
FIG. 2A

Gutters: Aluminum - **MISSING GUTTERS**- There were no gutters on the house at the time of the inspection. Gutters assist in shedding water away from the house to help prevent damage to the foundation, water intrusion into the basement and erosion to the ground around the foundation. Recommend a qualified professional install gutters (FIG. 2A).

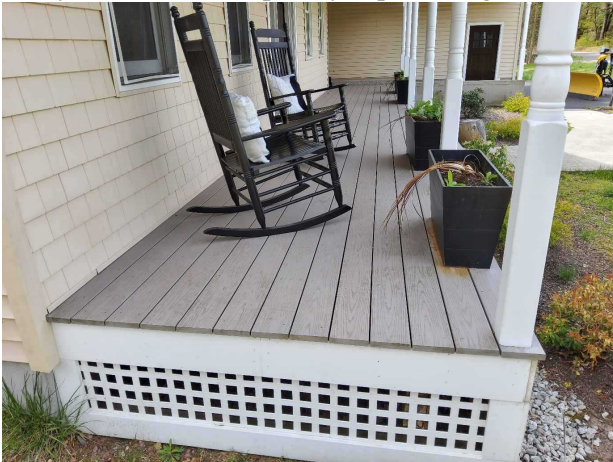
Deck: Composite - BELOW STANDARD- The deck has been built below today's acceptable building standards and is not safe in its current state. Recommend further evaluation and estimate to bring deck up to an acceptable building standard (Incorrect Joist Hangers, Ledger Board Incorrect) (FIG. 3A).

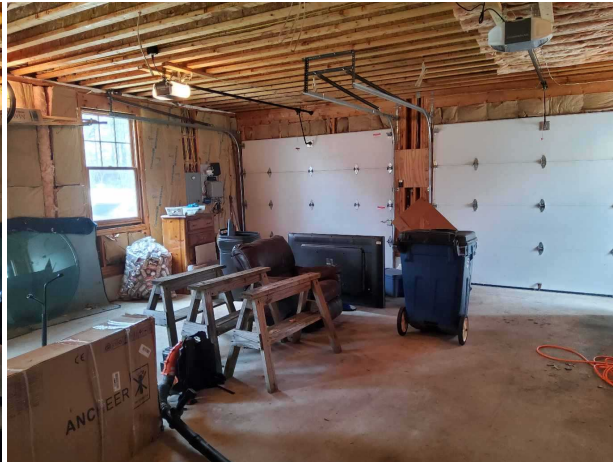
Garage Doors: Insulated aluminum - **SAFETY SENSOR INCORRECT HEIGHT-** A light beam automatic safety reverse on the garage door opener was installed incorrectly. This safety device is typically installed on either side of the garage door and is designed to reverse its movement when the light beam is interrupted in order to keep the garage door from harming pets and children. Recommend repair of garage door light beam by a qualified professional (FIG. 3C).

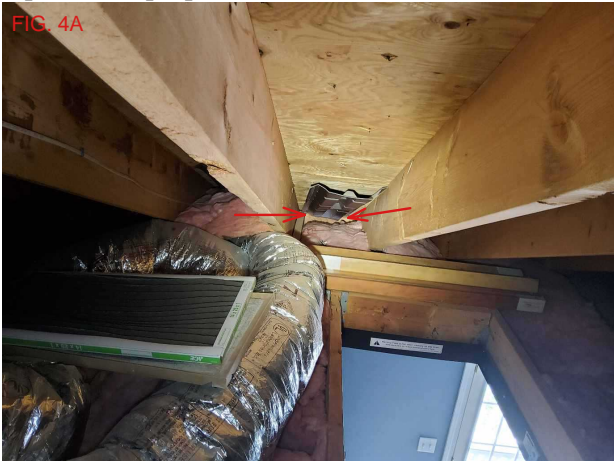
Ventilation: Ridge and soffit vents - VENTS- Several vents were installed incorrectly. It is recommended that the vents are repaired for proper installation (FIG. 4A).

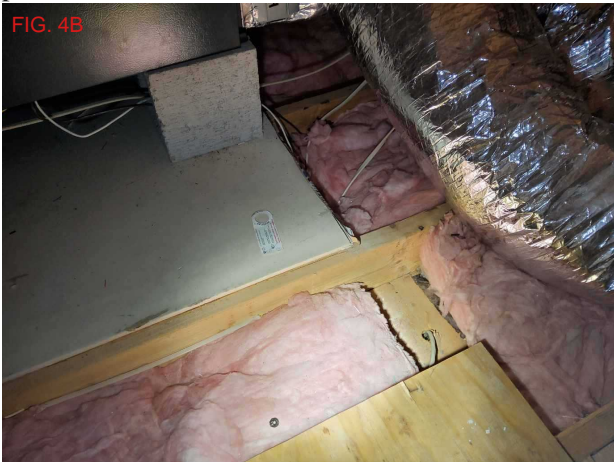
Insulation: Batts - UNINSULATED ATTIC ENTRY POINT- The entry point to the attic space was not insulated. The entry point should be insulated to prevent heat transfer into the attic space. Recommend adding insulation board to the attic entry point. INSUFFICIENT INSULATION- Recommend installing additional attic insulation which may reduce heating and cooling costs. Today's standard requires approximately 12-16 inches of loose fill insulation in the attic. Consult with a qualified insulation professional for further evaluation (FIG. 4B).

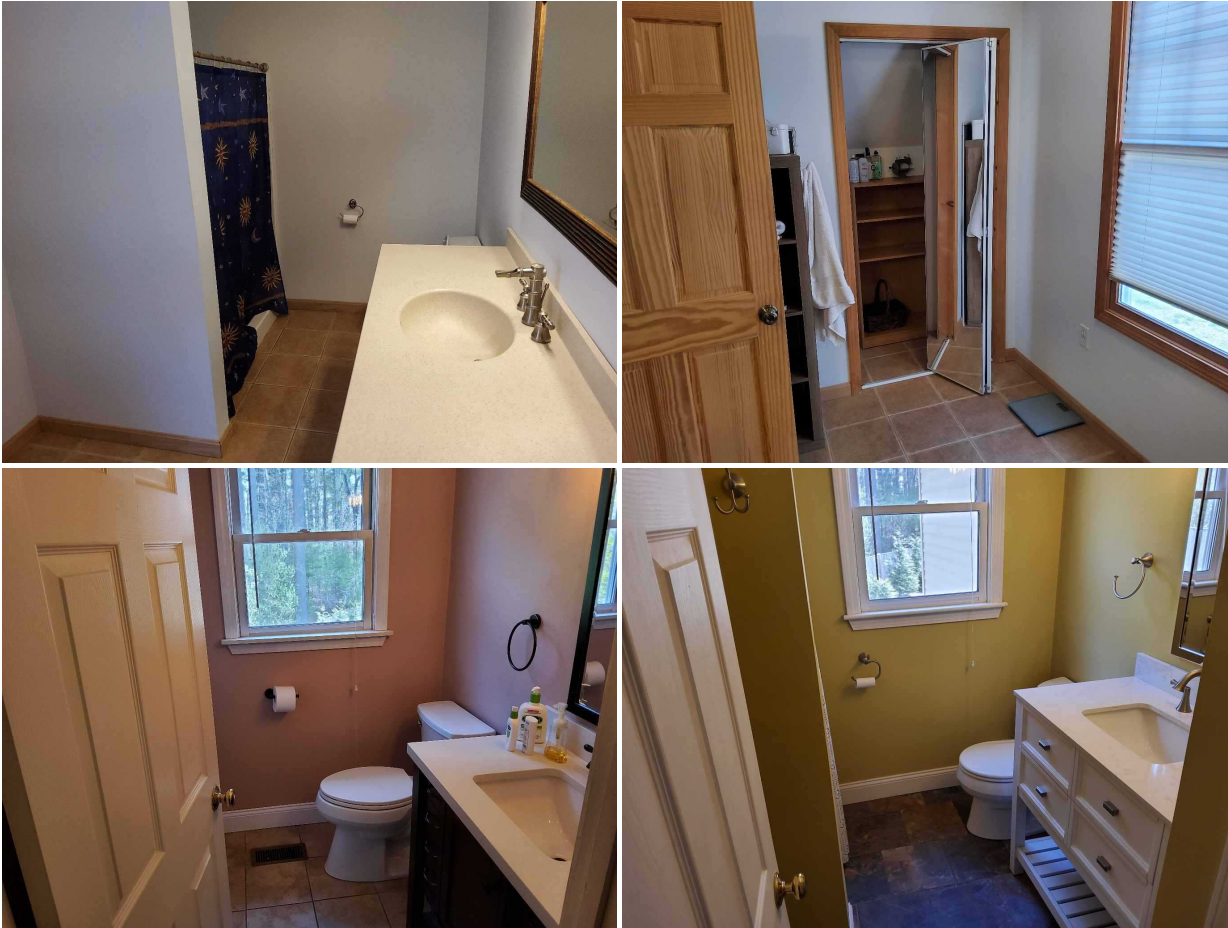
Items Identified: **SLOW DRAIN-** The sink drains has a reduced flow, indicating a possible obstruction in the drain line or vent. Recommend further evaluation by qualified plumbing professional (FIG. 5B).

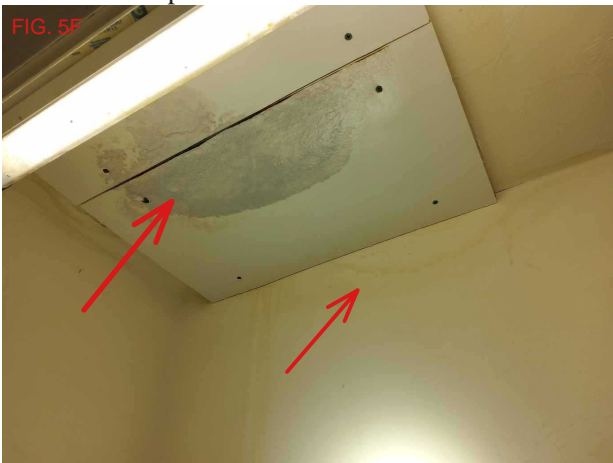
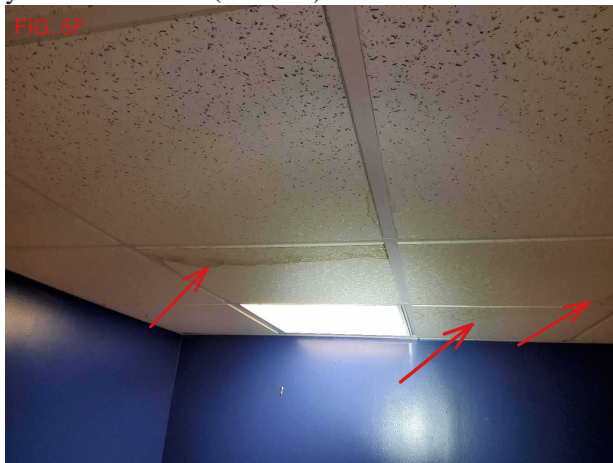
Items Identified: CEILING STAINS- Water stains were present on the ceiling of the structure. The stains appeared dry at the time of the inspection and should be monitored for any future moisture (FIG. 5F).

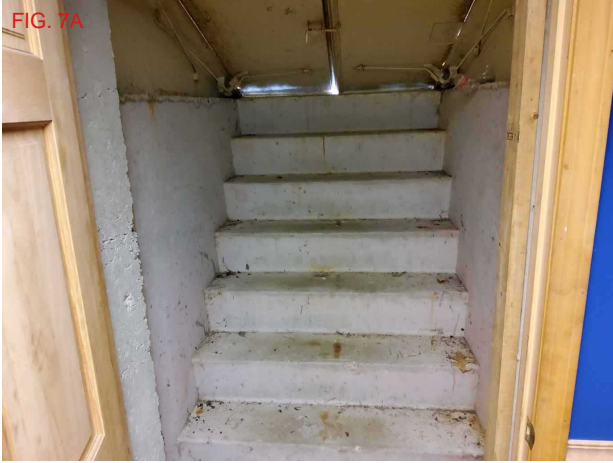
FIG. 7A

Items Identified: BULKHEAD DOOR- A bulkhead door was present. A bulkhead door does not indicate an issue. However it is common for a bulkhead door to allow water intrusion into the basement area. It is recommend to monitor the door and repair any areas which allow in water (FIG. 7A).

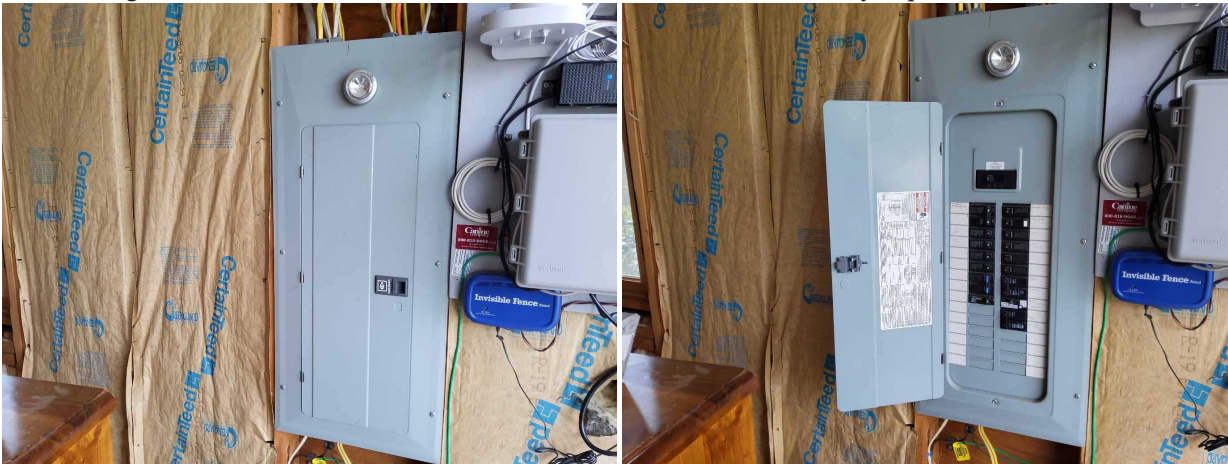
Manufacturer: Cutler-Hammer - DOUBLE TAPS- Double Taps were observed in the electrical service panel. A double tap is when two or more circuits are attached to the same breaker. Each circuit should have its own dedicated breaker to prevent overheating and ensure terminal contact. Recommend further evaluation by a qualified electrician (FIG. 8A).

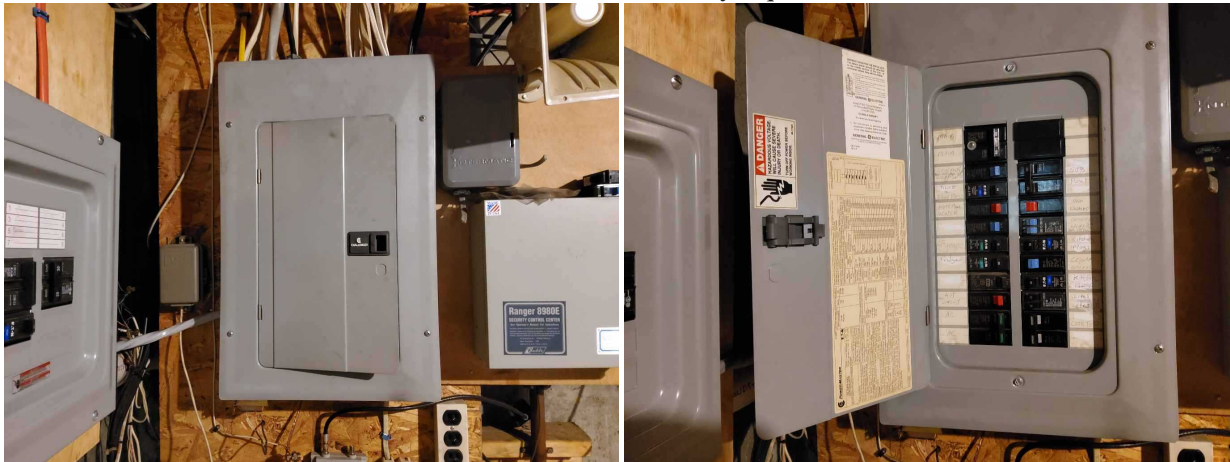
Manufacturer: Challenger - DOUBLE TAPS- Double Taps were observed in the electrical service panel. A double tap is when two or more circuits are attached to the same breaker. Each circuit should have its own dedicated breaker to prevent overheating and ensure terminal contact. Recommend further evaluation by a qualified electrician (FIG. 8B).

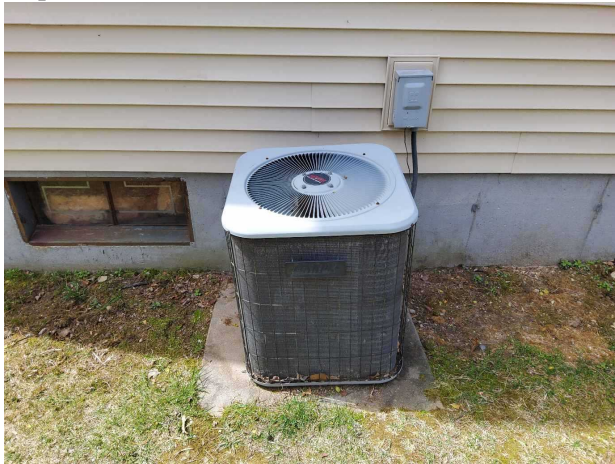
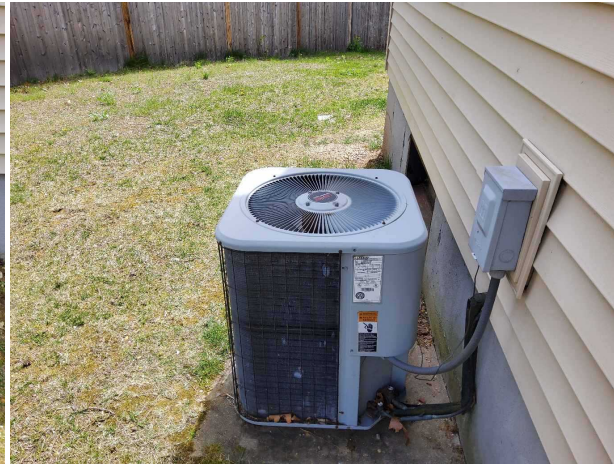
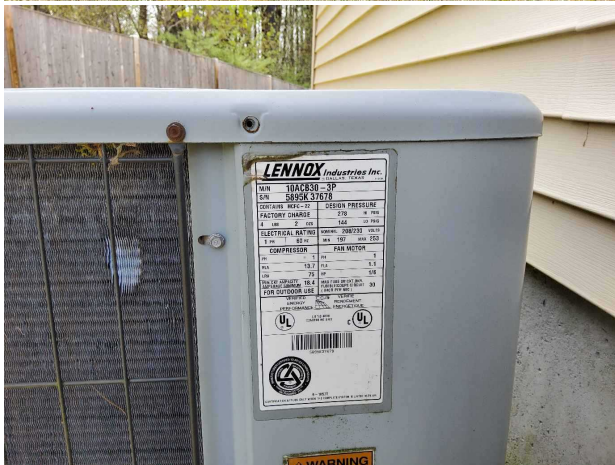
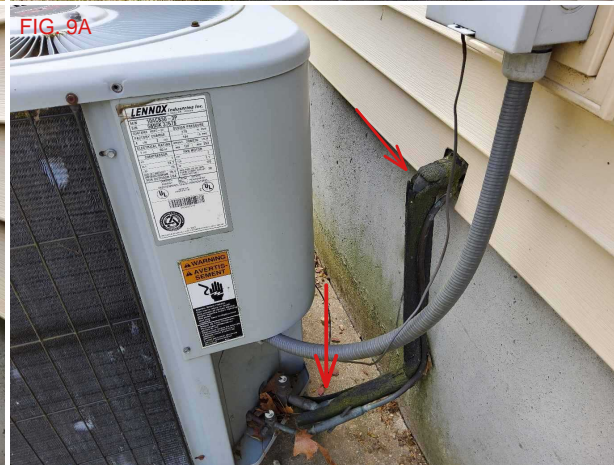
DAMAGED INSULATION- The insulation on the exterior air conditioning line set is damaged and/or missing. This may affect the efficiency of the system and should be replaced (FIG. 9A).

EXISTING BEYOND LIFE- Due to the age of the furnace, it is considered to be existing beyond design life. Recommend budgeting replacement for financial future.

MAINTENANCE- The HVAC appears to need routine maintenance due to its poor operation/ appearance at the time of the inspection.

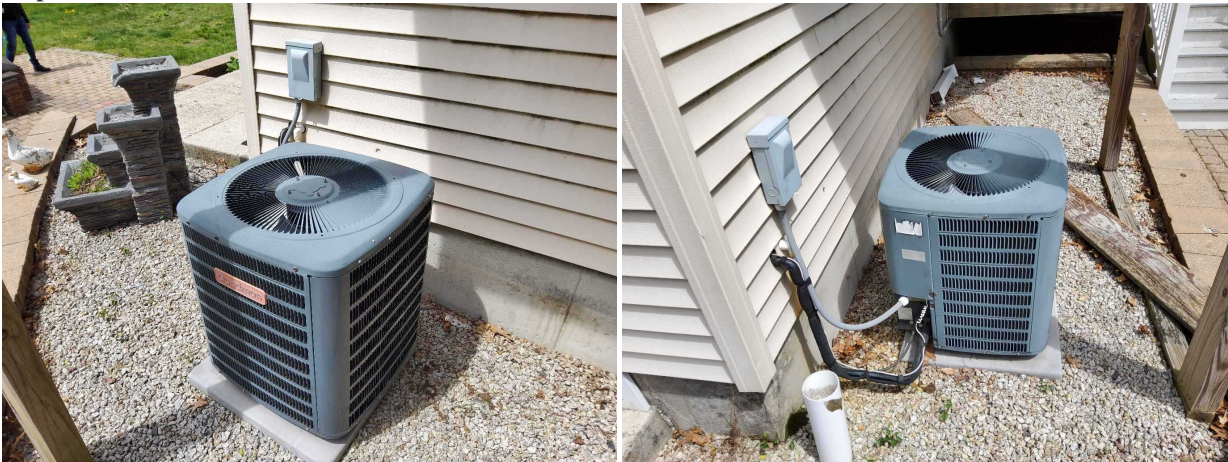
DAMAGED INSULATION- The insulation on the exterior air conditioning line set is damaged and/or missing. This may affect the efficiency of the system and should be replaced (FIG. 9B).

EXISTING BEYOND LIFE- Due to the age of the furnace, it is considered to be existing beyond design life. Recommend budgeting replacement for financial future.

MAINTENANCE- The HVAC appears to need routine maintenance due to its poor operation/ appearance at the time of the inspection.

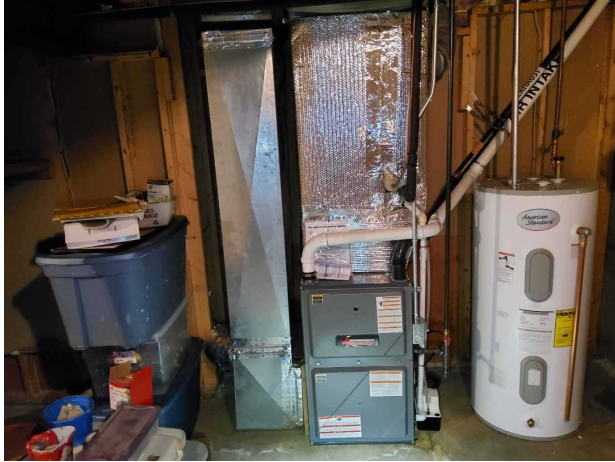
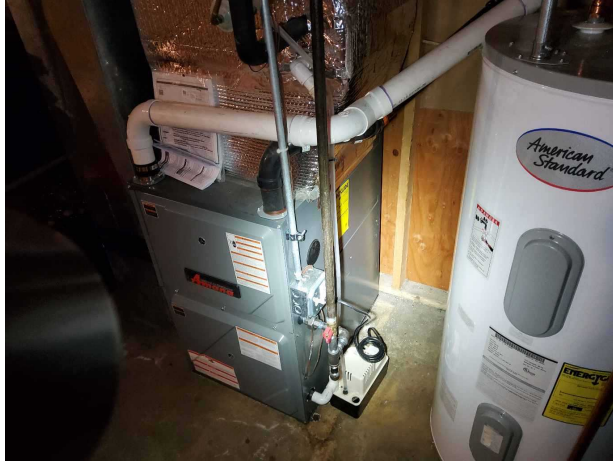
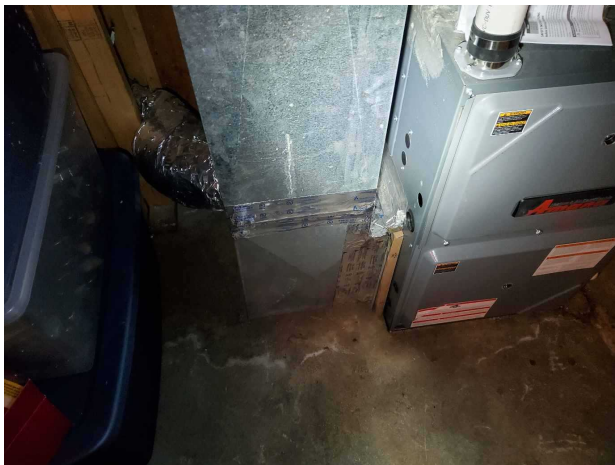
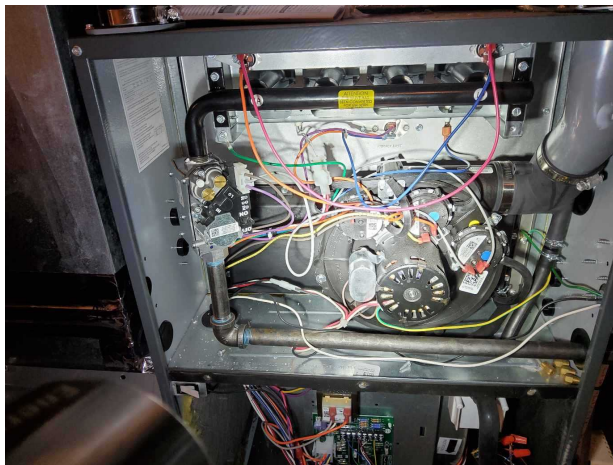
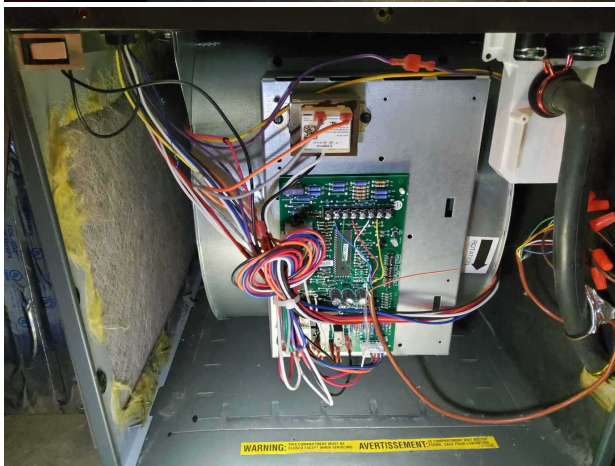
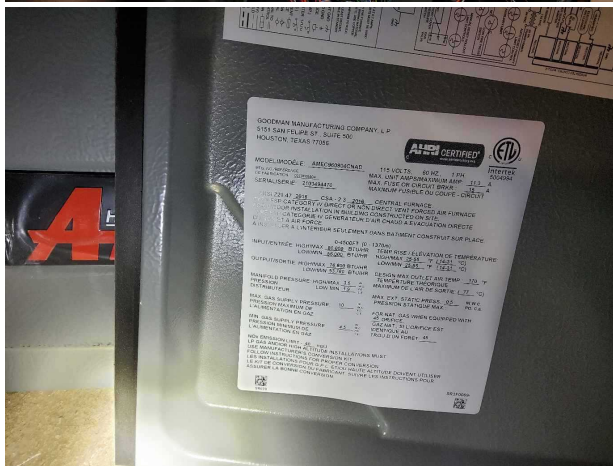
Air Handler System Operation: Functional- Propane - CONDENSATE LEAK- A condensate leak was observed on the air handler drain line. Recommend repair by a qualified HVAC technician (FIG. 9C).

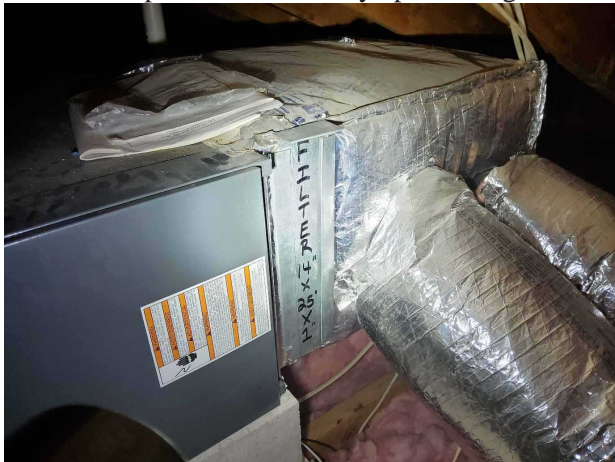
Filter: Disposable - **DIRTY FILTER-** The air filter is extremely dirty and should be replaced. Prolonged operation of the HVAC system with a dirty filter can cause internal damage to the compressor valves that may not be observable during the inspection. Operating the HVAC system with a dirty filter may also damage the air handler. Recommend having the HVAC system cleaned and serviced for this reason (FIG. 9D).

FILTER REPLACEMENT- The filter was in need of replacement at the time of the inspection. Clogged and dirty air filters affect the performance and efficiency of the HVAC system. A clogged filter can also cause damage to the system. The filter should be replaced immediately upon taking ownership of the structure.

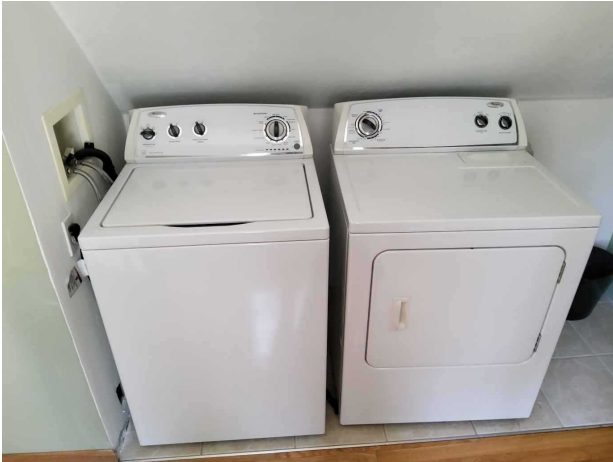
Washer Machine/ Dryer: Present - **DRYER HOSE-** Recommend replacing existing dryer hose with a rigid metal dryer hose venting system. The dryer hose present tends to collect moisture and dryer lint resulting in overheating.
