Home Inspection Report

**Inspected by:
Nick Tolman
Aventine Home Inspections**

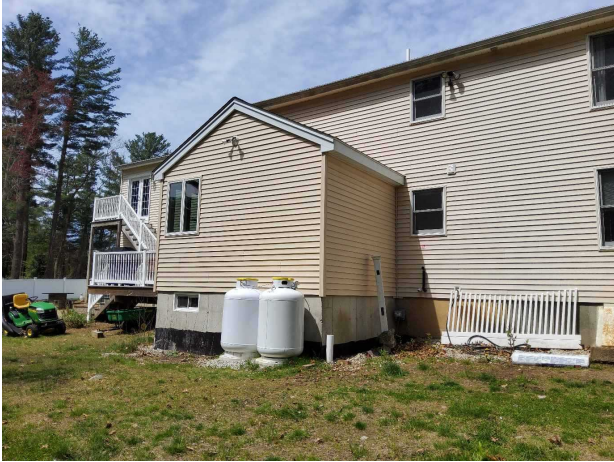
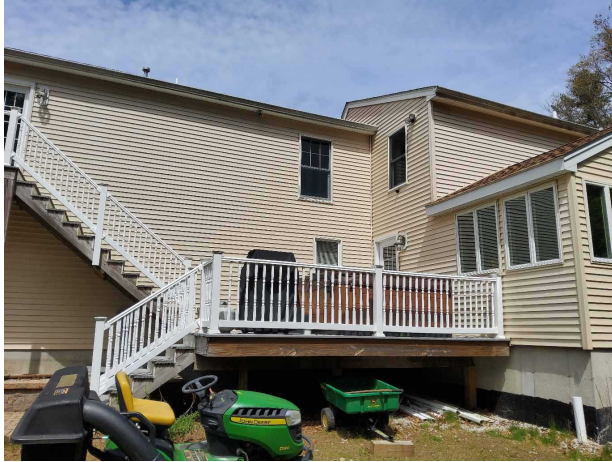
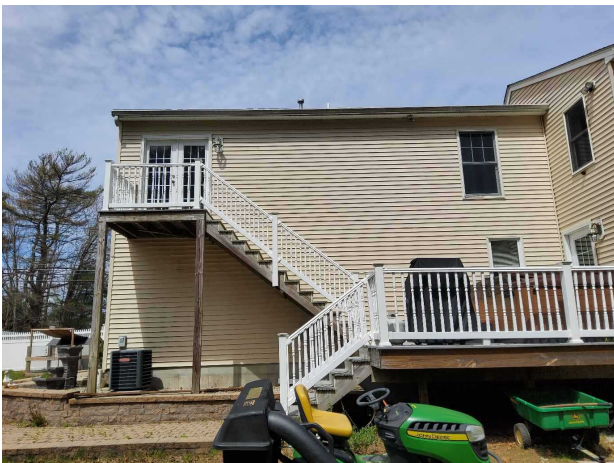
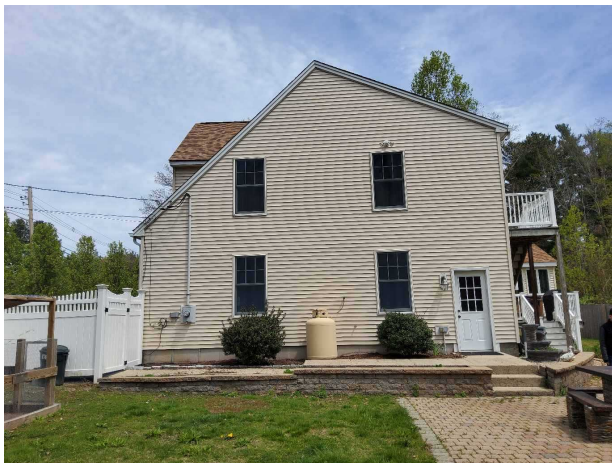
Type: Vinyl siding - **LOOSE SIDING-** Loose siding was noted on the structure's exterior. The siding should be repaired by a qualified professional (FIG. 1A).

SIDING HOLES- Holes were noted in the siding of the structure's exterior. The area should be repaired by a qualified professional to prevent water intrusion (FIG. 1B).

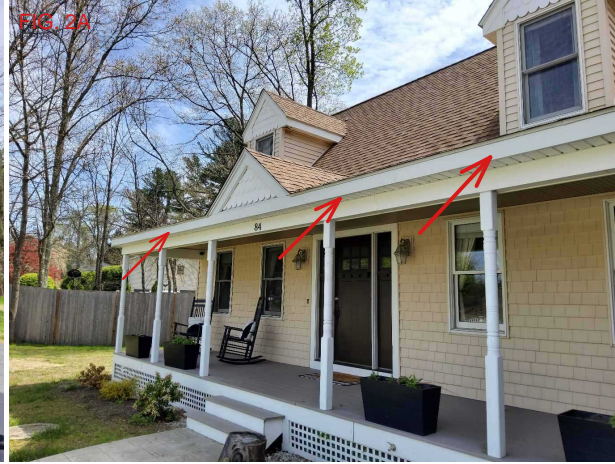
FIG. 2A

Gutters: Aluminum - **MISSING GUTTERS**- There were no gutters on the house at the time of the inspection. Gutters assist in shedding water away from the house to help prevent damage to the foundation, water intrusion into the basement and erosion to the ground around the foundation. Recommend a qualified professional install gutters (FIG. 2A).

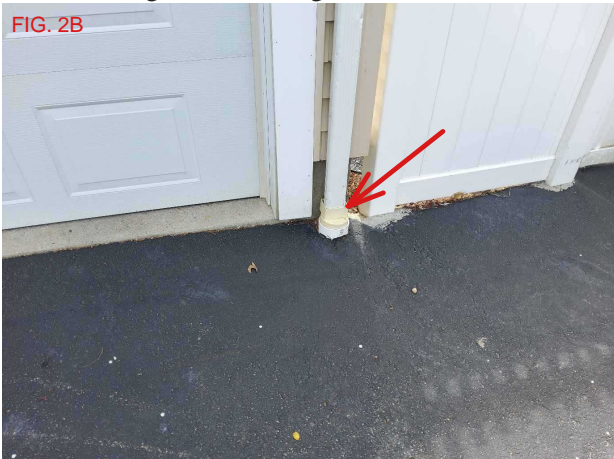
FIG. 2B

Downspouts: Aluminum - **DOWNSPOUT TERMINATION**- There are downspouts around the structure that are draining into the ground with no conclusive termination point. Recommend locating termination points to ensure proper drainage (FIG. 2B). **MISSING DOWNSPOUT**- A missing downspout was observed at the time of the inspection. The downspout allows the collected water in the gutter flow to ground surface. The downspout(s) should be installed to avoid further damage (FIG. 2C).

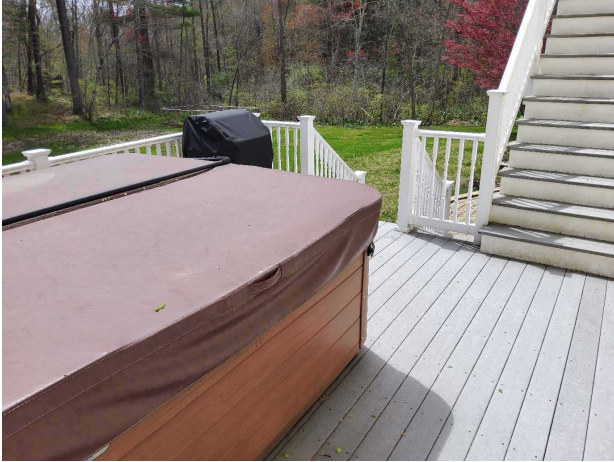
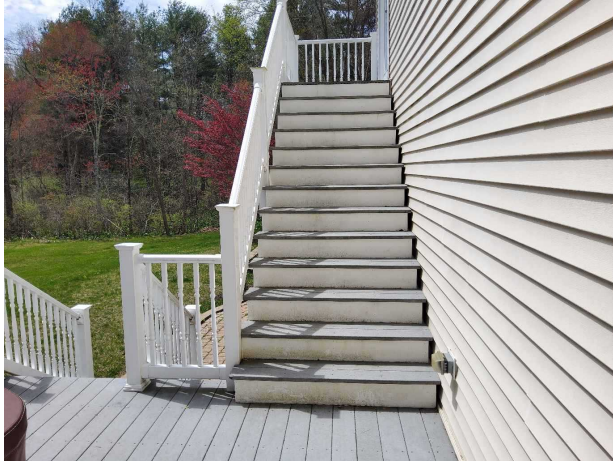
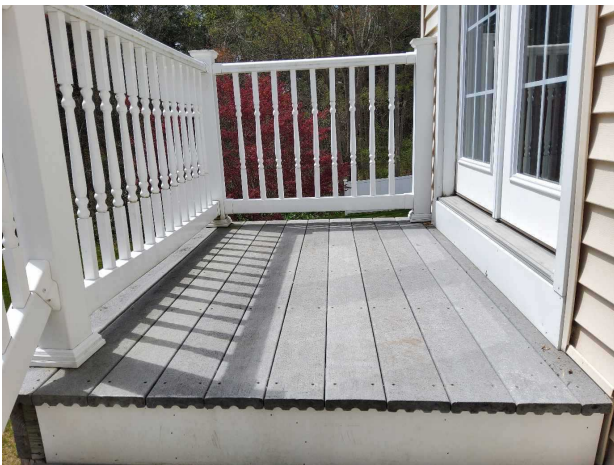
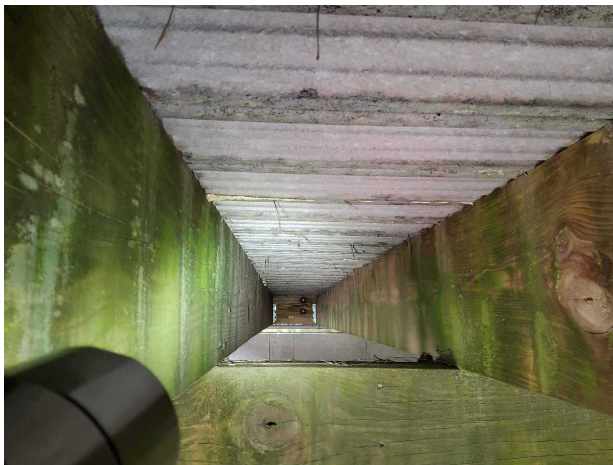
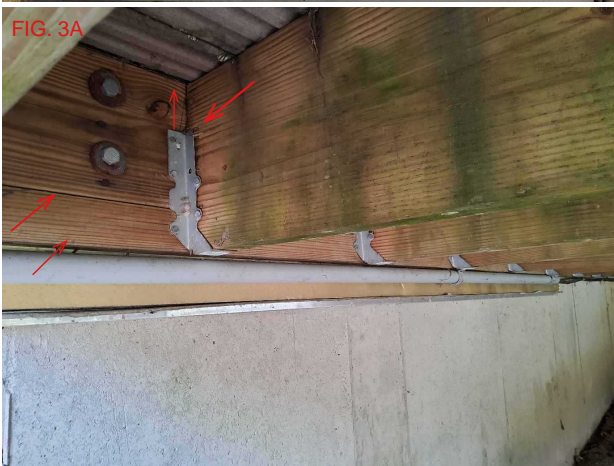
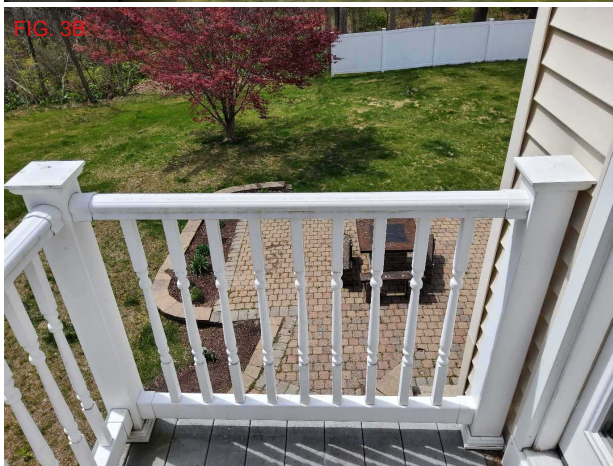
Deck: Composite - BELOW STANDARD- The deck has been built below today's acceptable building standards and is not safe in its current state. Recommend further evaluation and estimate to bring deck up to an acceptable building standard (Incorrect Joist Hangers, Ledger Board Incorrect) (FIG. 3A).

LOOSE HANDRAIL- The handrail on the stairs is loose or otherwise not secured. The handrail should be properly secured for safety. Recommend repair by a qualified general contractor (FIG. 3B).

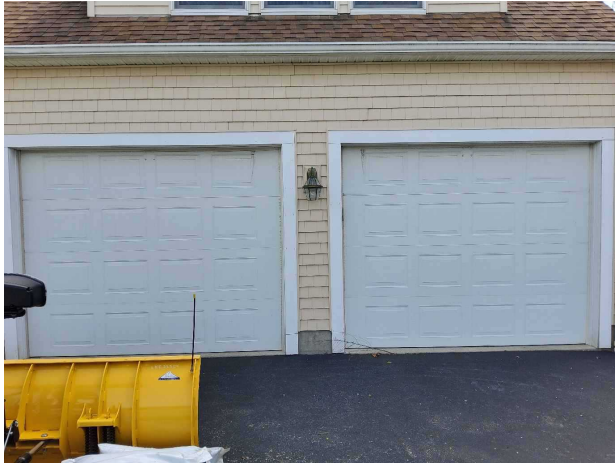
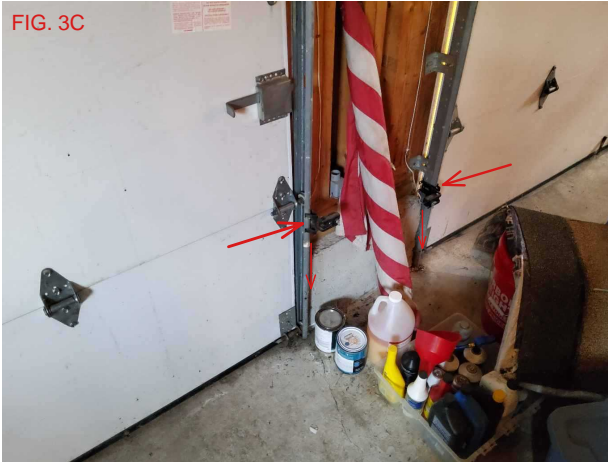
Garage Doors: Insulated aluminum - **SAFETY SENSOR INCORRECT HEIGHT-** A light beam automatic safety reverse on the garage door opener was installed incorrectly. This safety device is typically installed on either side of the garage door and is designed to reverse its movement when the light beam is interrupted in order to keep the garage door from harming pets and children. Recommend repair of garage door light beam by a qualified professional (FIG. 3C).

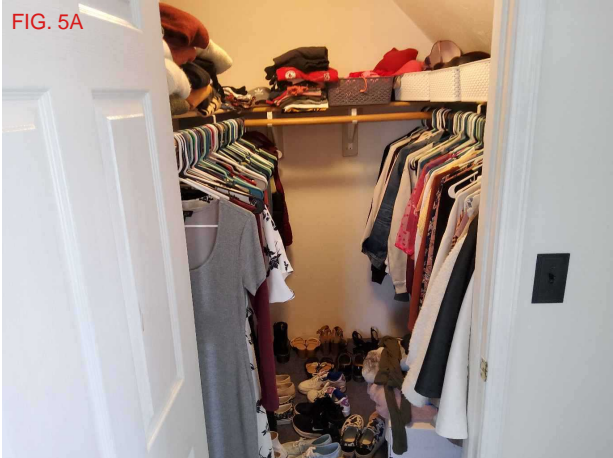
FIG. 5A

Items Identified: LIVING AREA CLUTTER- Select areas of the home were cluttered with items and furniture at the time of the inspection. The obstructed areas were not able to be inspected (FIG. 5A).

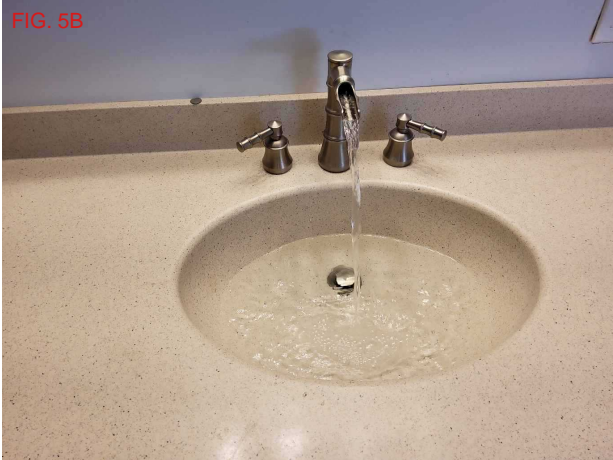
FIG. 5B

Items Identified: **SLOW DRAIN-** The sink drains has a reduced flow, indicating a possible obstruction in the drain line or vent. Recommend further evaluation by qualified plumbing professional (FIG. 5B).

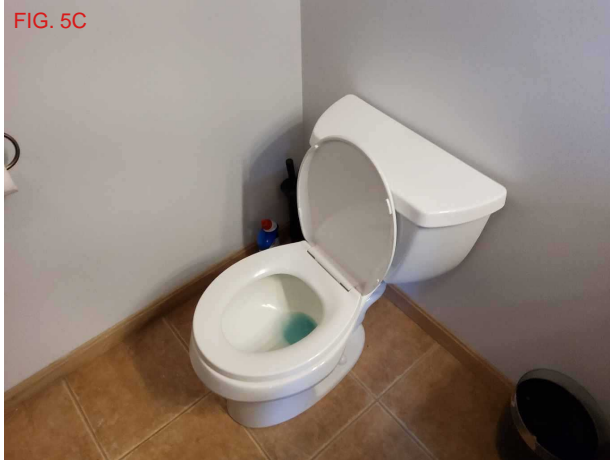
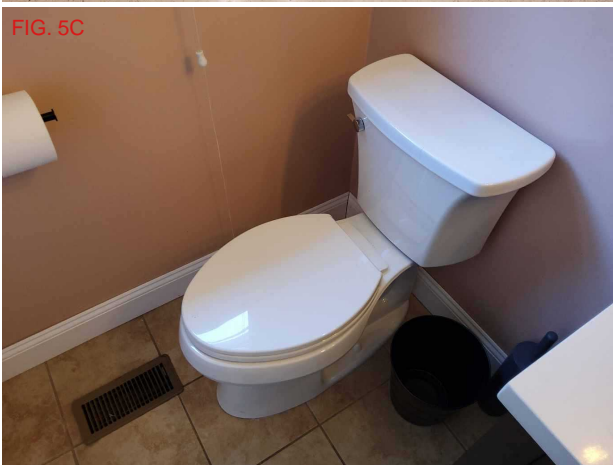
FIG. 5C

LOOSE TOILET- The toilet was loose at the floor. Although the toilet was not leaking at the time of the inspection, a loose toilet may lead to water intrusion. It is recommended that the wax seal is replaced and the toilet is tightened to the floor. Be careful not to over-tighten the toilet to the floor as damage to the toilet may occur (FIG. 5C).

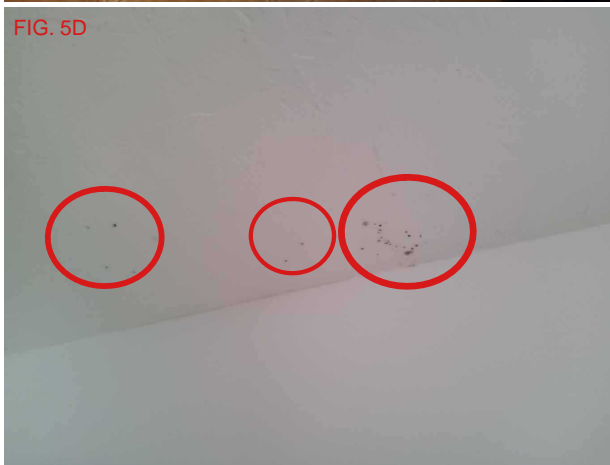
FIG. 5D

MOLD-LIKE GROWTH- Mold-like growth is visible in the structure. The EPA has helpful information that may assist the buyer (<http://www.epa.gov/moldresources.html>) Recommend having the areas tested to determine the presence, type, and relative concentration of mold spores, and professionally remediate by a licensed mold remediation professional. A mold remediation professional may uncover additional areas or issues requiring repair or remediation (FIG. 5D).

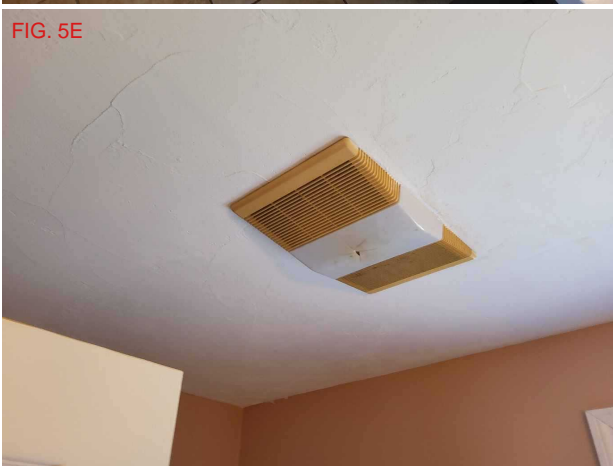
FIG. 5E

BATHROOM FAN NON-FUNCTIONAL- Bathroom fan does not function when switch is in the 'ON' position. The bathroom fan's function is to remove excess moisture from the area and expel the moisture to the exterior reducing the risk of mold growth and damage to the area. Further evaluation is recommended by a qualified contractor (FIG. 5E).

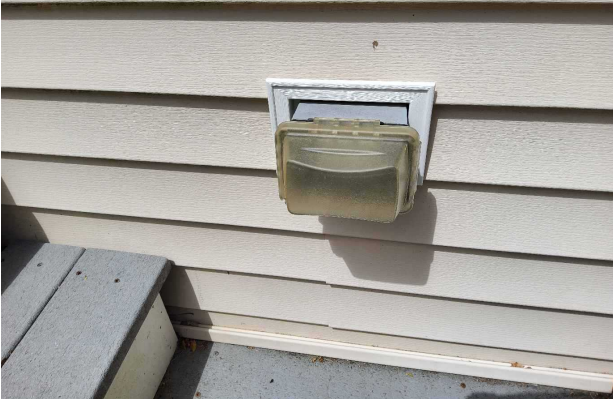
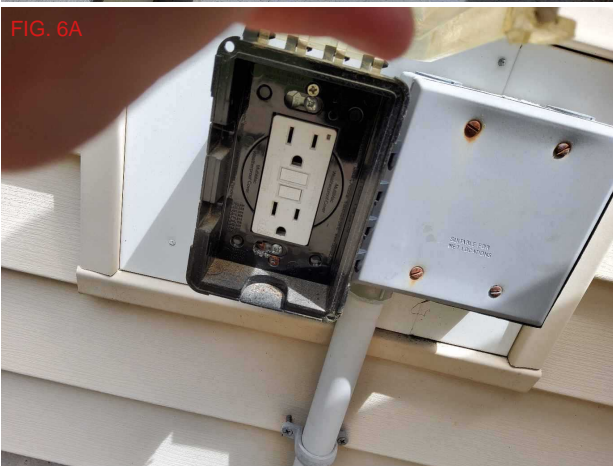
FIG. 6A

Electrical: DEFECTIVE GFCI- A GFCI outlet located in the home is defective and should be replaced. Defective GFCI outlets may be a potential safety hazard (FIG. 6A).

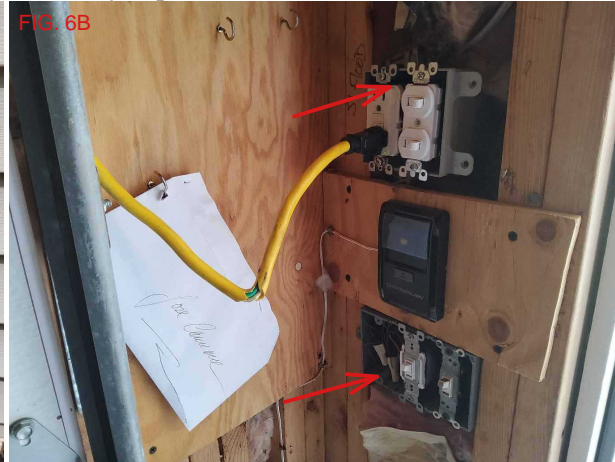
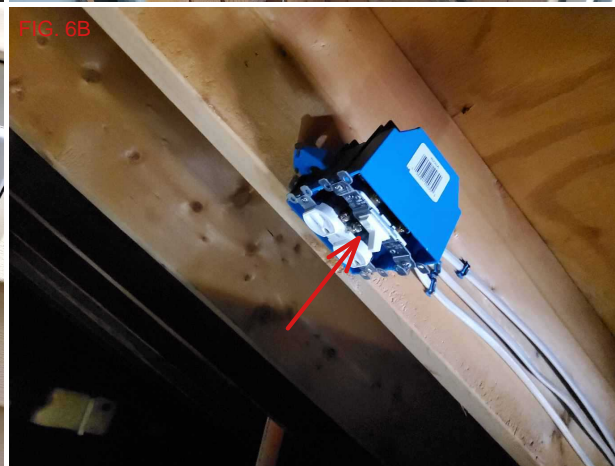
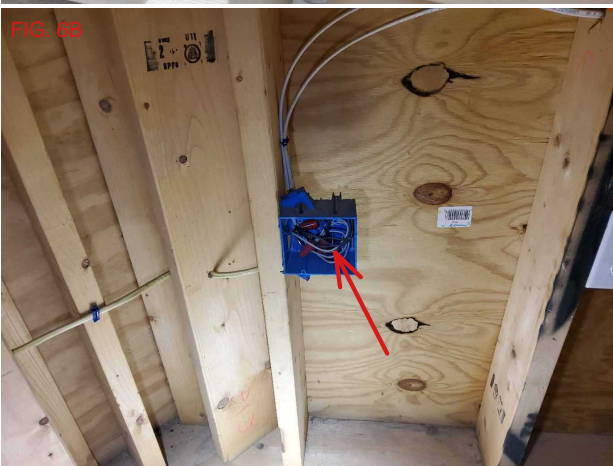
FIG. 6B

UNCOVERED JUNCTION BOX- Uncovered junction boxes were present. All electrical boxes should be covered to avoid a shock hazard. Electrical related repairs should be performed by a qualified electrician (FIG. 6B).

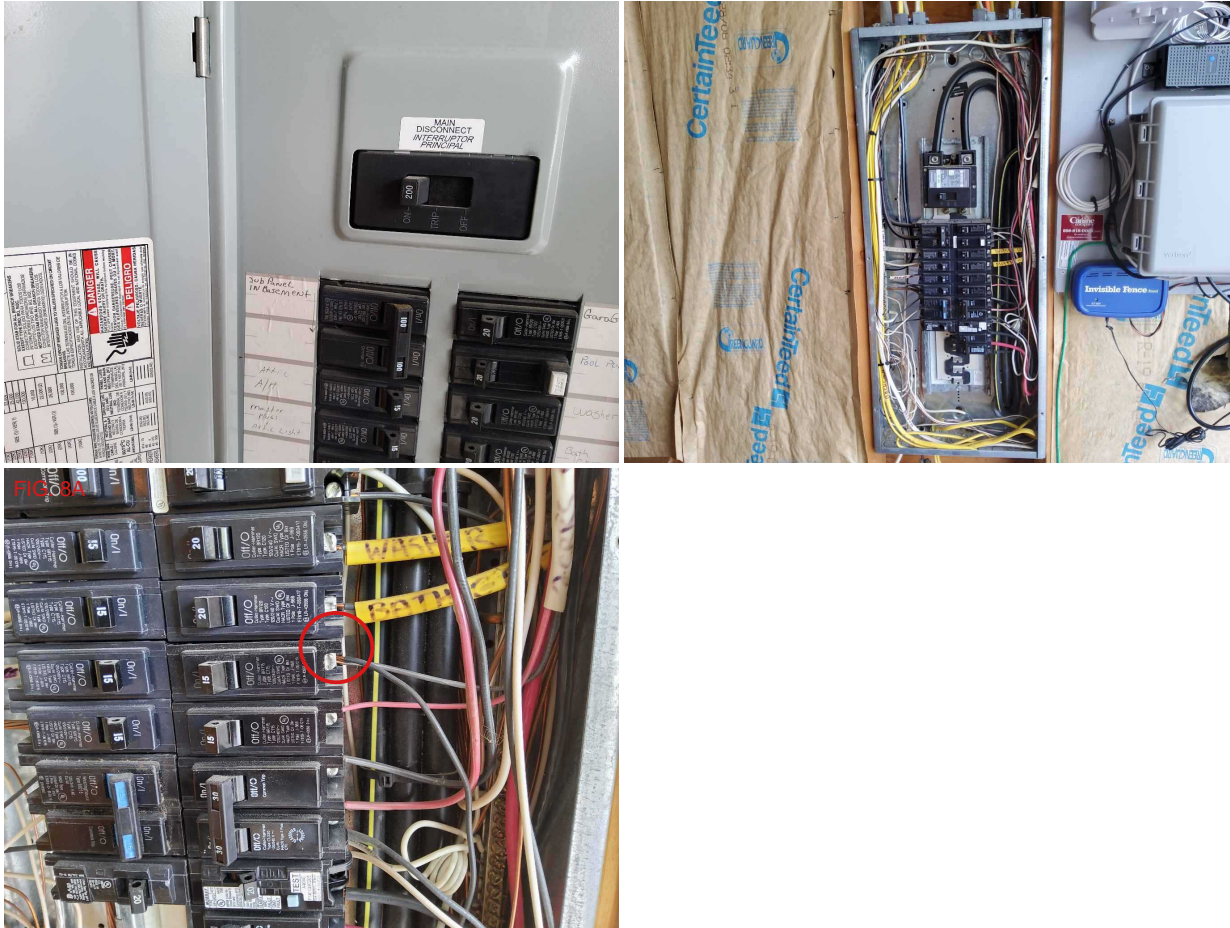
Manufacturer: Cutler-Hammer - DOUBLE TAPS- Double Taps were observed in the electrical service panel. A double tap is when two or more circuits are attached to the same breaker. Each circuit should have its own dedicated breaker to prevent overheating and ensure terminal contact. Recommend further evaluation by a qualified electrician (FIG. 8A).

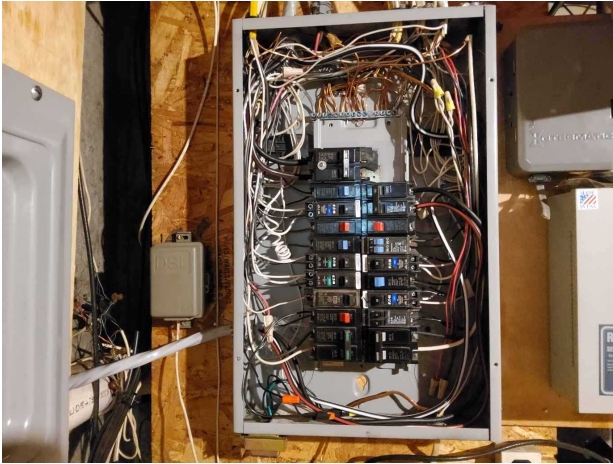
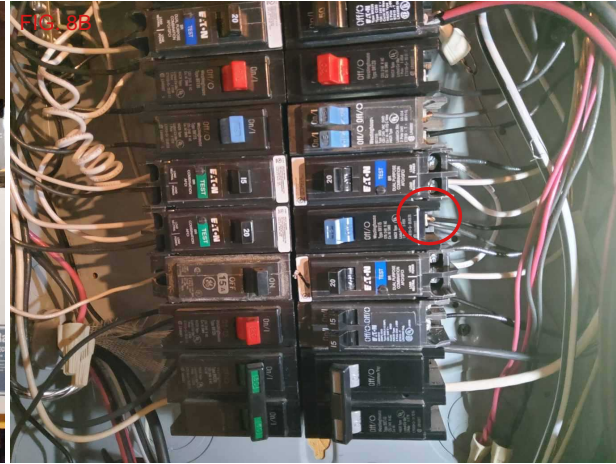
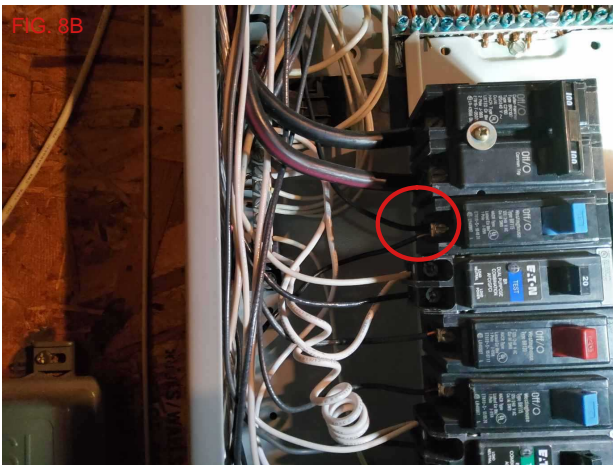
Manufacturer: Challenger - DOUBLE TAPS- Double Taps were observed in the electrical service panel. A double tap is when two or more circuits are attached to the same breaker. Each circuit should have its own dedicated breaker to prevent overheating and ensure terminal contact. Recommend further evaluation by a qualified electrician (FIG. 8B).

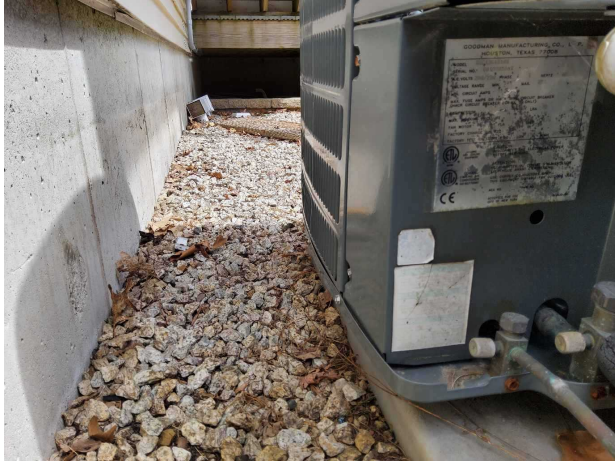
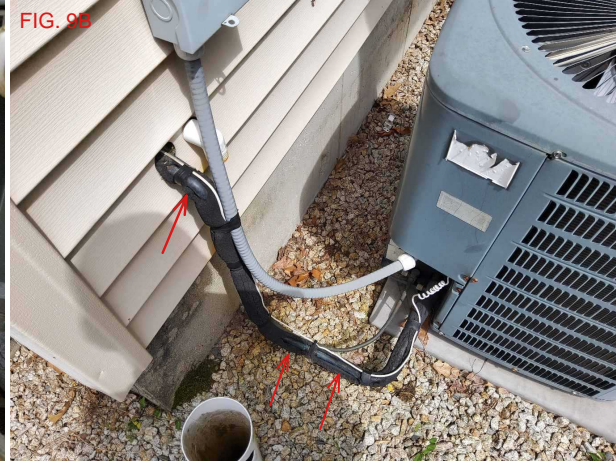
DAMAGED INSULATION- The insulation on the exterior air conditioning line set is damaged and/or missing. This may affect the efficiency of the system and should be replaced (FIG. 9B).

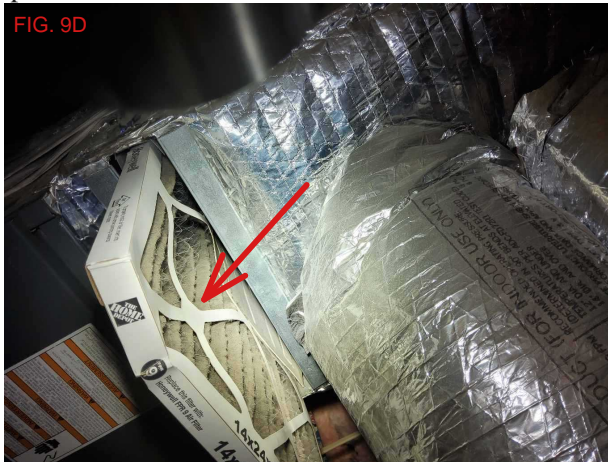
Filter: Disposable - **DIRTY FILTER-** The air filter is extremely dirty and should be replaced. Prolonged operation of the HVAC system with a dirty filter can cause internal damage to the compressor valves that may not be observable during the inspection. Operating the HVAC system with a dirty filter may also damage the air handler. Recommend having the HVAC system cleaned and serviced for this reason (FIG. 9D).

FILTER REPLACEMENT- The filter was in need of replacement at the time of the inspection. Clogged and dirty air filters affect the performance and efficiency of the HVAC system. A clogged filter can also cause damage to the system. The filter should be replaced immediately upon taking ownership of the structure.

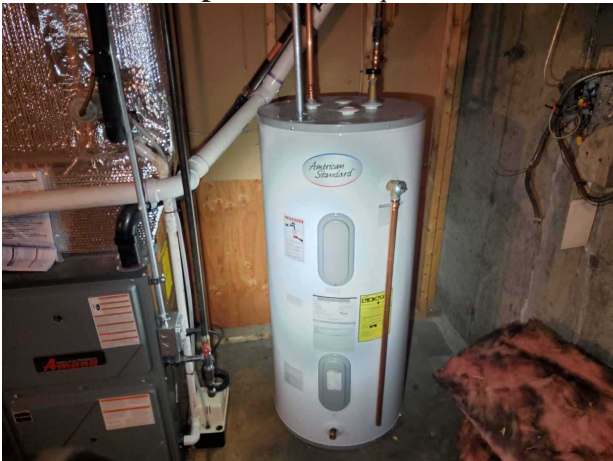
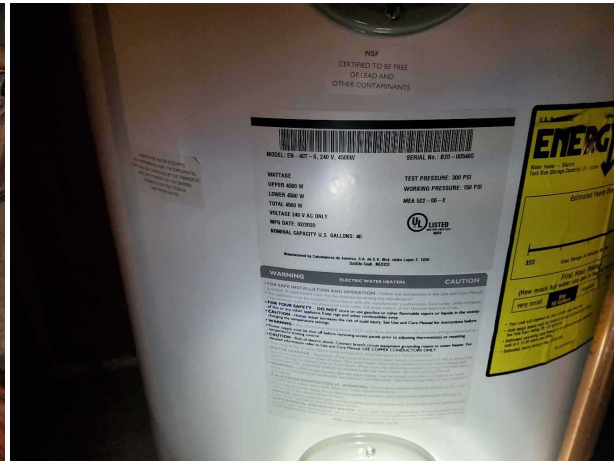
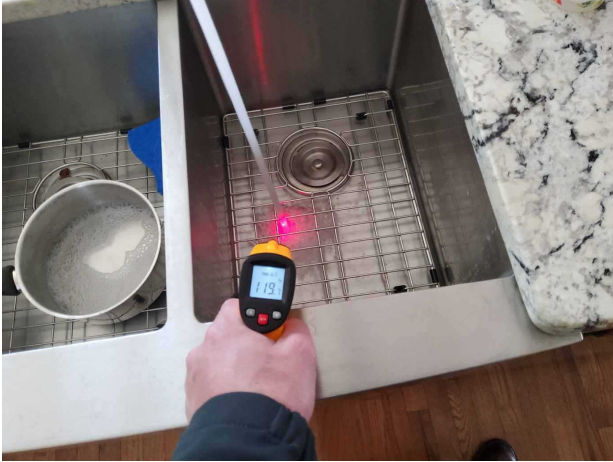
Water Heater Operation: Adequate

Manufacturer: American Standard
Model Number: EN-40T-6 **Serial Number:** B20-005465
Type: Electric **Capacity:** 40 Gal.
Approximate Age: 2 Years **Area Served:**
TPRV and Drain Tube: Copper

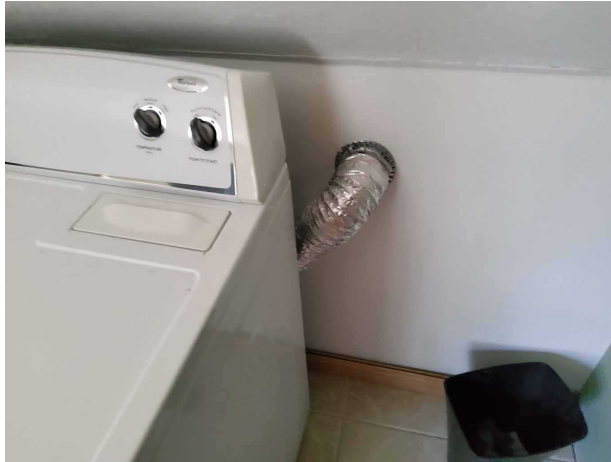
Washer Machine/ Dryer: Present - **DRYER HOSE-** Recommend replacing existing dryer hose with a rigid metal dryer hose venting system. The dryer hose present tends to collect moisture and dryer lint resulting in overheating.
